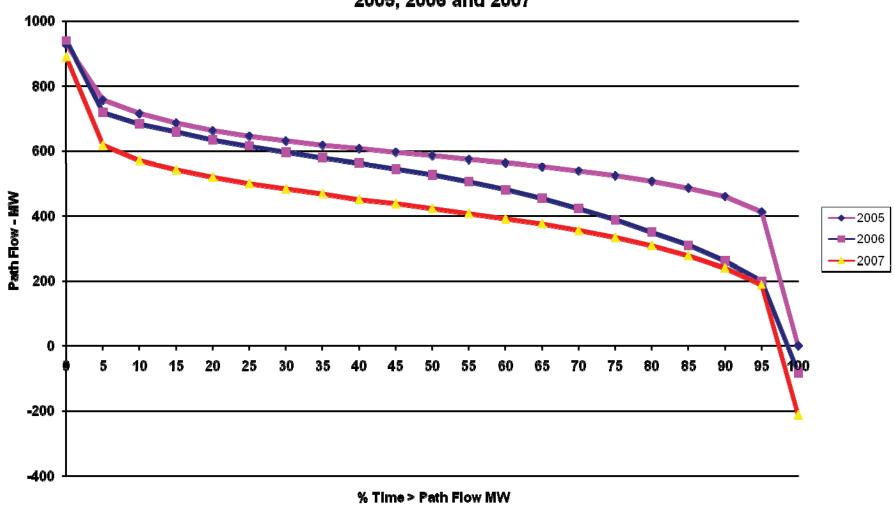
Figure II-42 Southern New Mexico - Path 47 Actual Path Flow 2005, 2006 and 2007
